MAPPING OF LANDSLIDE HAZARD DISTRIBUTION IN ALO WATERSHED GORONTALO REGENCY

Risman Jaya^a, Ahmad Syamsu Rijal^a

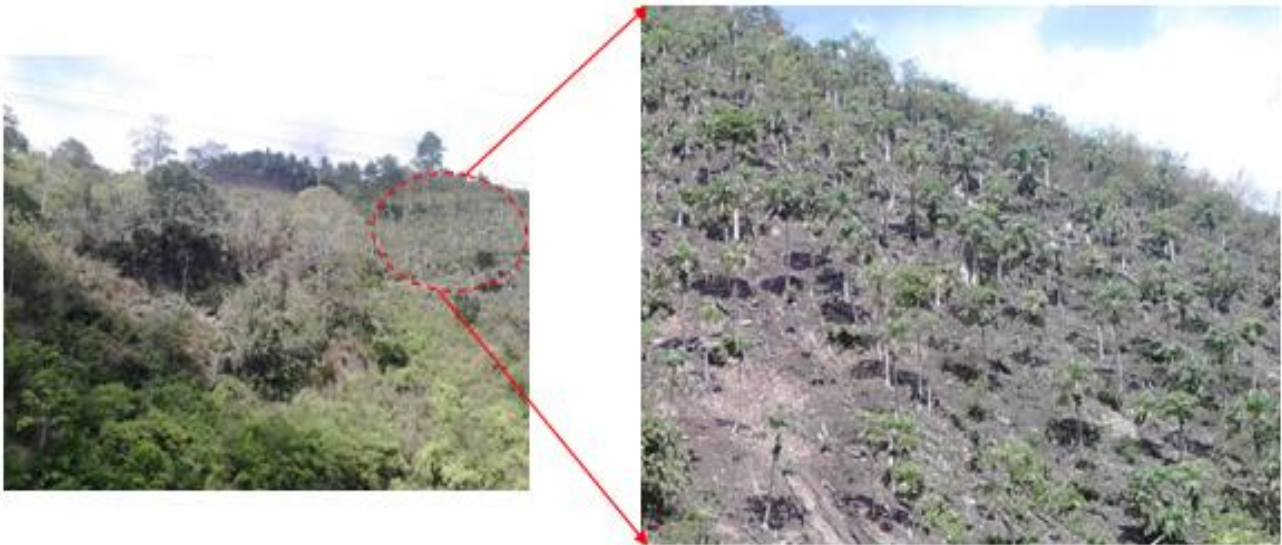
Figure 5. Hill with a slope > 25% which is converted into a papaya plantation

The existence of vegetation also becomes a very influential factor. Based on the results of the field survey, the landslide occurred in an area that has experienced land conversion. Land conversion is intended to convert hills with a slope of >25% (Figure 5) to plantation land and seasonal agriculture, such as corn, papaya, and peanuts as well as the cultivation of teak trees. The morphological distribution in the Alo watershed is classified into 5 classes namely 0-8%, 8-15%, 15-25%, 25-40% and >40% (Figure 6). High landslide susceptibility classes are caused by areas that have high landslide susceptibility and are supported by slope >30% which tends to be unstable towards land stability (Asiki, Maryati, & Akase, 2019).

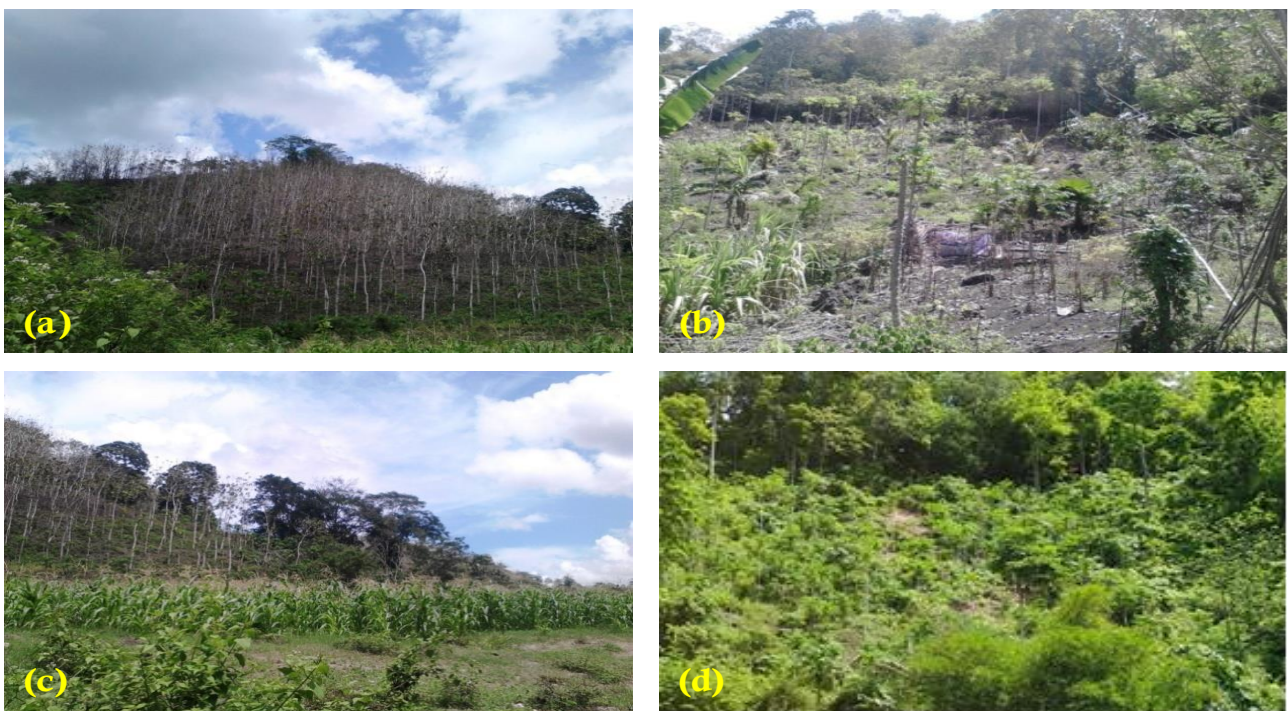
Figure 8. Conditions for land use in the Alo Watershed; (a) White teak cultivation, (b) Papaya plants in slope > 30%, (c) Corn plants on the river's edge, (d) Papaya plants in slope > 35%.

can be proven by the amount of eroded land by light to severe erosion. A large amount of land management in hilly areas contributes to the instability of land durability in maintaining its consistency to the carrying capacity of soil material loads which in the end causes landslides. The role of land conversion has an impact on the loss of vegetation in the hills of Alo watershed which is able to withstand soil stability against the slope that can accelerate the occurrence of landslides. Here are some documentations of hills that have experienced land conversion (Figure 8).
