# Jambura Geoscience Review

# Analysis Slope Stability Using RMR and SMR Method in Nupaomba Area Tanantovea Donggala

Landslide disasters frequently occur in the Nupabomba area due to its steep slopes and its role as a primary access road for the local community. This study aims to analyze slope stability using the Rock Mass Rating (RMR) and Slope Mass Rating (SMR) methods to assess the potential for landslides. The research was conducted at coordinates (Universal Transverse Mercator) UTM 829117.90 - 831853.89 mE and 9920980.82 -9920308.34 mS. Data collection involved field measurements using the scanline method, focusing on discontinuities, lithology, and rock strength. The results indicate that at Station 01, the slope consists of slate rock with an RQD value of 70% and UCS of 23 MPa. The calculated RMR value is 58, placing it into Class III (fair rock), with an SMR value of 55.4, indicating partially stable conditions. Meanwhile, at Station 02, the slope consists of phyllite rock with an RQD value of 70% and UCS of 52 MPa. The RMR value is 62, classifying it as Class II (good rock), and the SMR value is 61.6, indicating a stable condition. These findings provide crucial insight

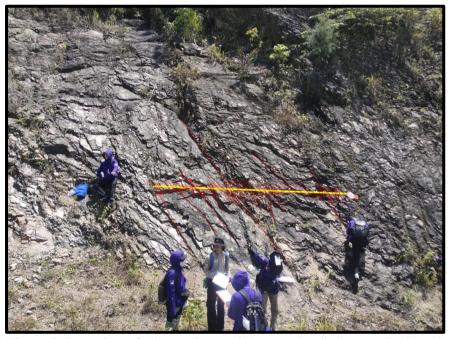
At Station 01, the slope consists of slate rock, which has a fresh brownish-black color, a lepidoblastic texture, and a mineral composition of biotite (45%), hornblende (25%), quartz (15%), and plagioclase (15%). Using a geological compass, the measured slope angle was 54°, with a second angle of 41° measured at a height of 13.5 meters (Figure 2).

Figure 2. Location of observation and data retrieval slope at Station 01

Further laboratory testing using the Schmidt hammer estimated the Uniaxial Compressive Strength (UCS) value at 23 MPa (Table 1). The results from the RMR calculation placed the slope into Class III (fair rock) with a value of 58, indicating a moderate stability category (Table 2). The SMR value was determined as 55.4, categorizing the slope as partially stable (Table 3).

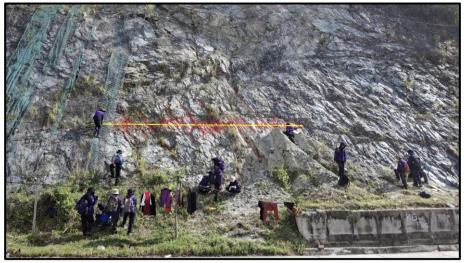
At Station 02, the lithology consists of phyllite rock, which is characterized by a fresh gray color, a lepidoblastic texture, and a mineral composition of biotite (45%), quartz (35%), and hornblende (20%). The slope angle measured at this station was 60°, with a second angle of 39°, and a total slope height of 9.3 meters (Figure 5).

**Table 4.** Location of observation and data retrieval slope at Station 02.

Laboratory results indicated that the UCS value was 52 MPa (Table 4). The RMR calculation resulted in a classification of Class II (good rock) with a score of 62 (Table 5). The SMR score was 61.6, indicating that the slope is stable (Table 6).
